**Flood Control Project Maintenance  
Levee Inspections****LMA District Cover Sheet****Spring 2013 Levee Inspection Results****Sutter Maintenance Yard Hamilton Bend**

**Levee Inspection Report By Mile - Spring 2013**

Waterway							Bank	Unit Miles	Inspection Start/End	Inspector	
Unit No. 01 Feather River Hamilton Bend							Right	3.22	04/23/2013 04/23/2013	Rick Burnett	
LMR No.	Levee Mile		Category	Item	* Location	** Rating	Action/Comment	GPS Latitude/Longitude		Issue No.	
	Start	End						Start	End	Photo	
1				Operations & Maintenance Manuals	CR	A Ma		° °	° °	7	
								DWR ID: DWR_ST0005_01_s_2013_7			
2				Emergency Supplies & Equipment	CR	A Ma		° °	° °	8	
								DWR ID: DWR_ST0005_01_s_2013_8			
3				Flood Preparedness & Training	CR	A Ma		° °	° °	9	
								DWR ID: DWR_ST0005_01_s_2013_9			
4	0.00	0.00		Vegetation	CR	A Ma	V1 : Control annual grass and weeds on the levee slopes and easements. Inspector Comments: Cobble Levee	° °	° °	1 Y	
								DWR ID: DWR_ST0005_01_s_2013_1			
5	0.36	0.36		Crown Surface / Depressions / Rutting	CR	M Ma	C2 : Repair depressions or ruts in the crown or slope.	39.444939 ° -121.641780 °	39.444939 ° -121.641780 °	2 Y

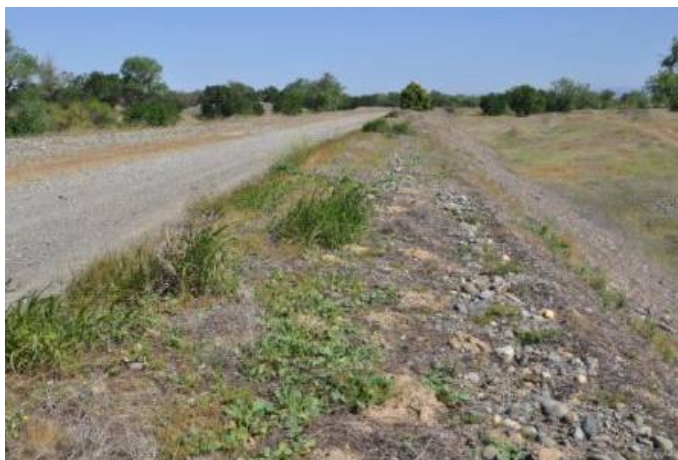
Levee Mile Report Line	4
Start Levee Mile	0.00
End Levee Mile	0.00
Location	Water Side
Category	
Item	Vegetation

Hamilton Bend - Cobble Levee

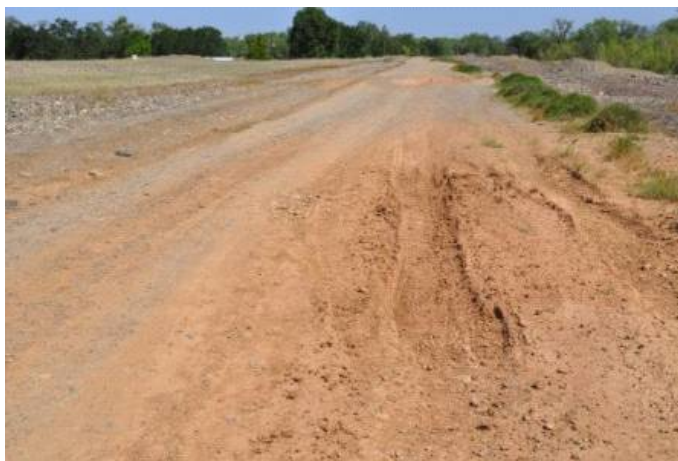
Levee Mile Report Line	5
Start Levee Mile	0.36
End Levee Mile	0.36
Location	Crown
Category	
Item	Crown Surface / Depressions / Rutting

Deep rut in crown. Repair prior to flood season.

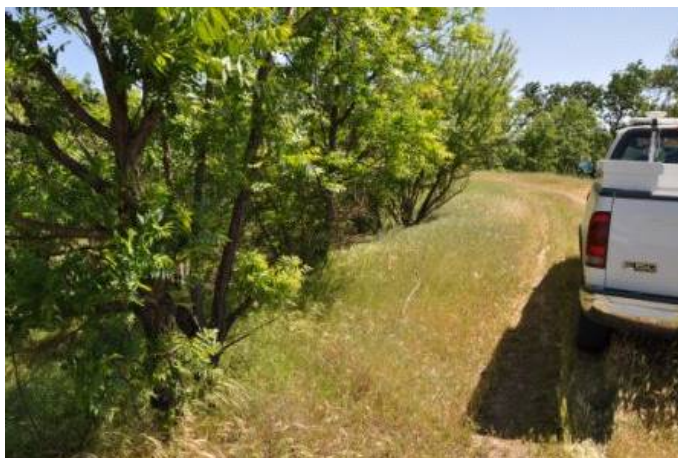
Levee Mile Report Line	6
Start Levee Mile	1.41
End Levee Mile	3.18
Location	Land Side
Category	
Item	Trim / Thin Trees

L/S trees.

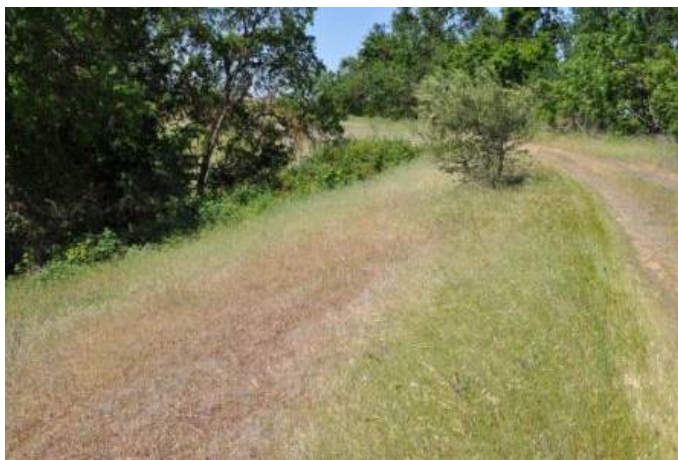
Levee Mile Report Line	7
Start Levee Mile	1.41
End Levee Mile	3.18
Location	Water Side
Category	
Item	Vegetation

Typical W/S vegetation.

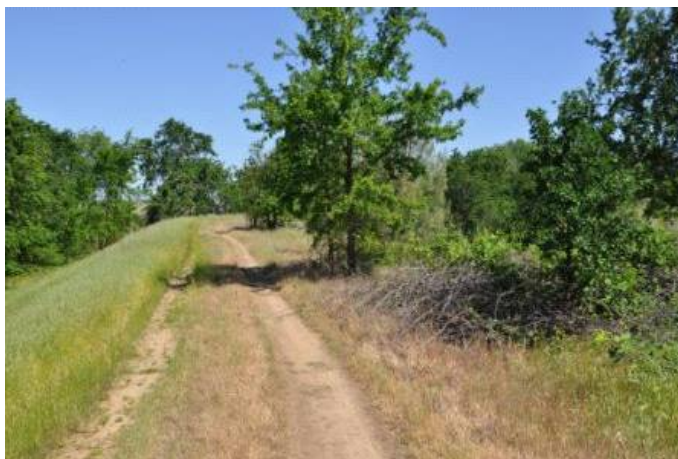
Levee Mile Report Line	8
Start Levee Mile	1.44
End Levee Mile	1.62
Location	Water Side
Category	
Item	Trim / Thin Trees

W/S trees.

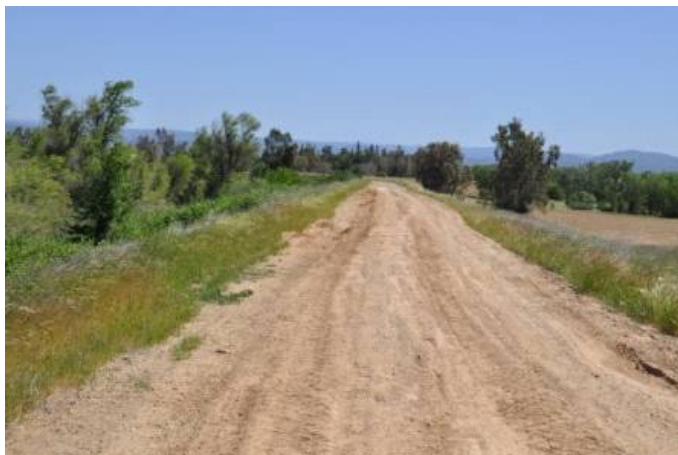
Levee Mile Report Line	9
Start Levee Mile	2.04
End Levee Mile	2.12
Location	Crown
Category	
Item	Crown Surface / Depressions / Rutting

Crown roadway damage.
